**A REVIEW OF
AIR RECEIVER CASUALTIES
WHERE THE COMPRESSOR
HAS BEEN MOUNTED
ON THE RECEIVER**

January, 1978

THE NATIONAL BOARD OF BOILER AND PRESSURE VESSEL INSPECTORS

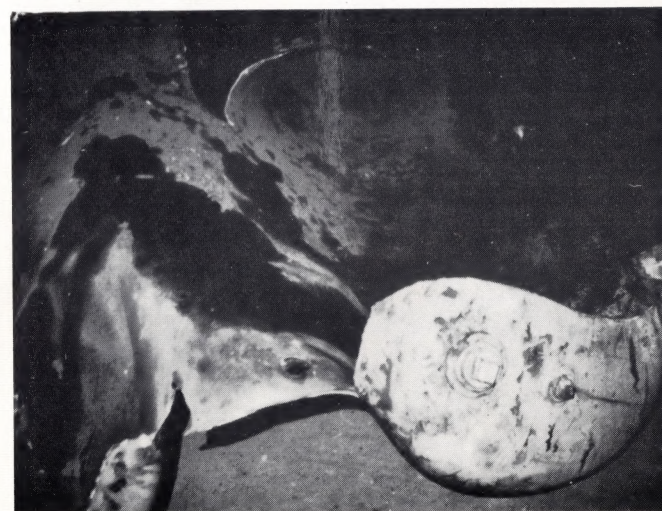
Vessel's present condition after failure.

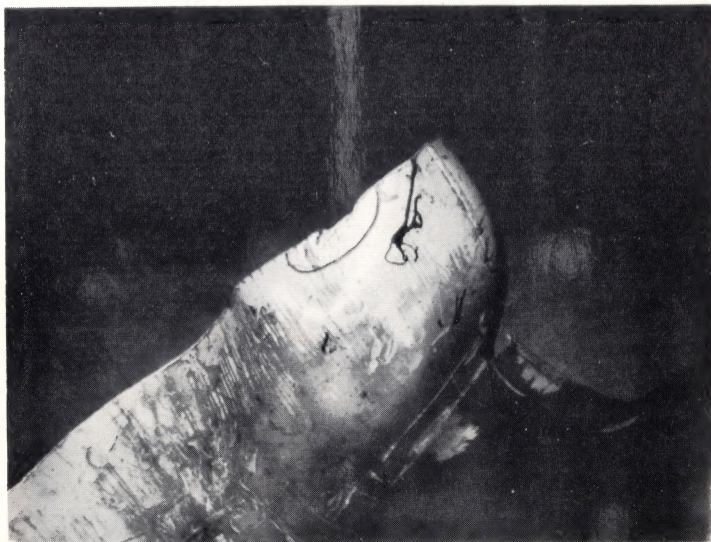
Area marked is where a leg had been rewelded. Note weld material on shell.

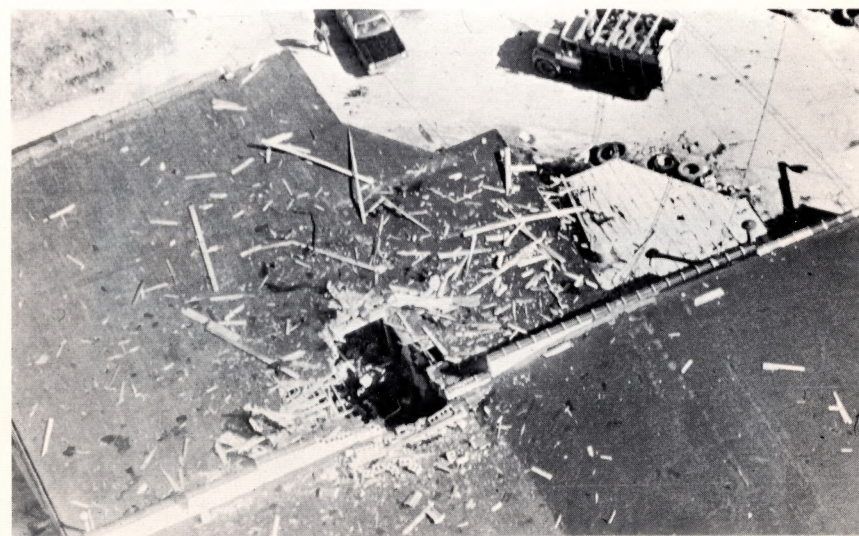
This air receiver exploded in a tire recapping plant apparently because of a crack propagated from a fillet weld joining a support to the tank, among the results being a hole in the roof big enough to drive a truck through.
